# Freshwater Parish Flood Report

# Freshwater Flood Report

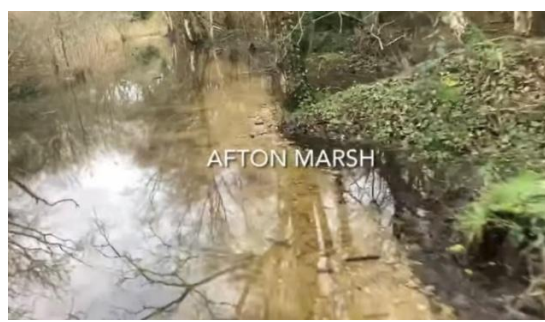
## Flooded Paths:

The public footpath / bridleway is to be part of The Greenway running from the Causeway to Freshwater Bay. This is often flooded making the Greenway impassable by bike or foot. The End of the Line Café say that the path to Causeway gets so badly flooded that people must use their land to get passed. The Greenway is at risk if the water levels are not reduced.

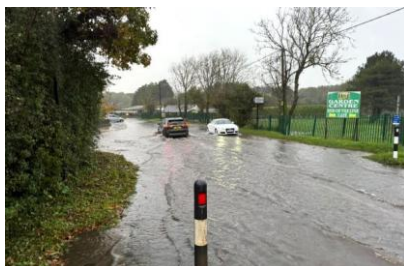
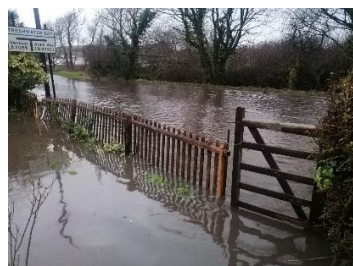
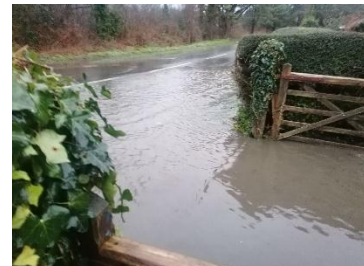
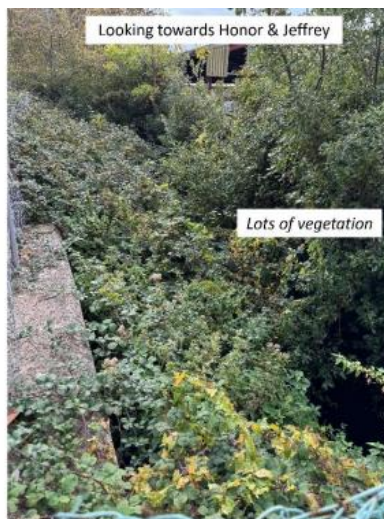
## Afton Road

These pictures show the main road that runs between Freshwater to Freshwater Bay.

It crosses the marshes and floods quite regularly, preventing access to the Afton Road civil amenity site, Tesco and to the main middle road route to Newport.

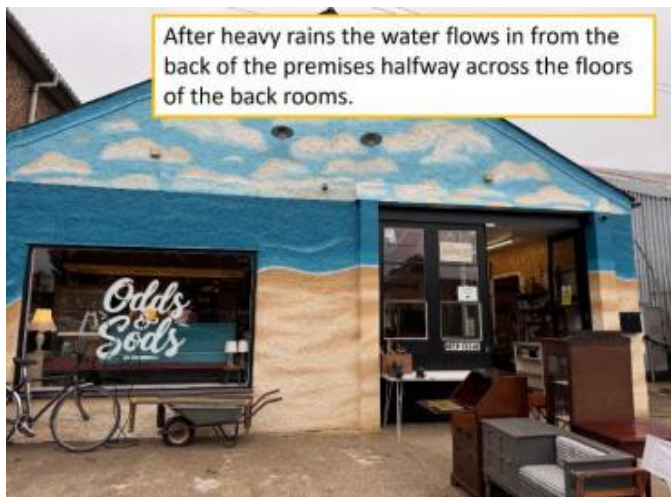
Teemill, to the south of the roundabout, has not suffered with flooding but the culvert is very overgrown with brambles and other vegetation that runs through their car park - at this stage the culvert is very deep, much deeper than when you look from Bowbridge / the bridge beneath Hooke Hill. This will be slowing down the flow in the culvert.

Clearly no-one has cleared that section in several years.

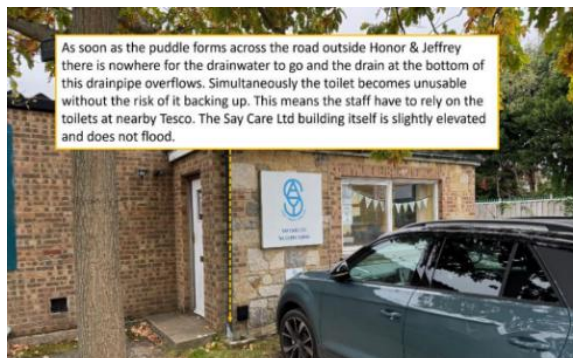
### Say Care Ltd

As soon as the puddle forms across the road outside Honor & Jeffrey there is nowhere for the drainwater to go and the drain at the bottom of this drainpipe overflows. Simultaneously the toilet becomes unusable without the risk of it backing up. This means the staff have to rely on the toilets at nearby Tesco. The Say Care Ltd building itself is slightly elevated and does not flood.

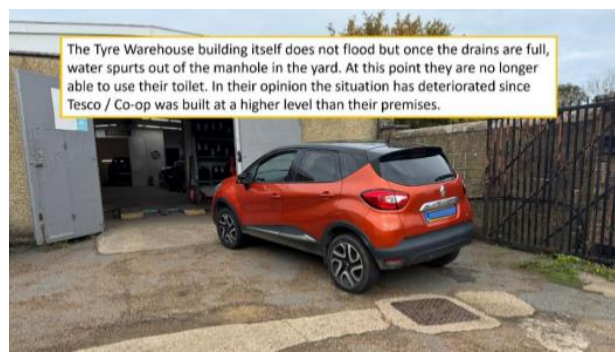
### The Tyre Warehouse

The Tyre Warehouse building itself does not flood but once the drains are full, water spurts out of the manhole in the yard. At this point they are no longer able to use their toilet. In their opinion the situation has deteriorated since Tesco / Co-op was built at a higher level than their premises.

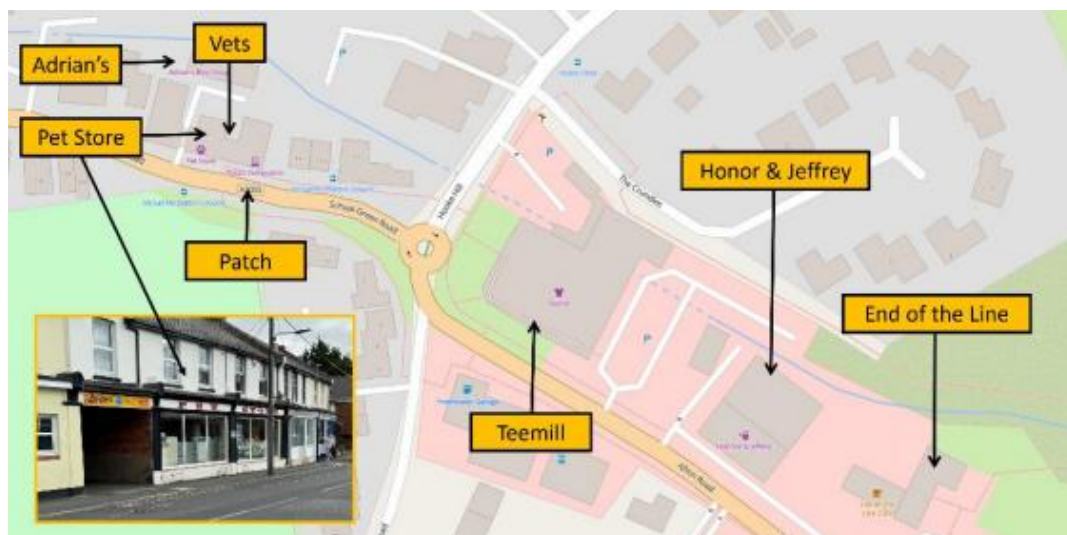
**The businesses at the bottom end of School Green Road, close to the roundabout, are suffering worst. They have a culvert running behind their property that is silted up and clogged in several places with vegetation.**

**Patch Computers, The Pet Store, Carisbrooke Vets and Adrian’s Bike Shop were all flooded on 30th August 2025 and speak of previous flood occasions.**

At the Pet Store (Mark Mocroft) water flowed in from the roadside of the building and came in as far as the bottom of the counter. Fortunately, Mark was around and managed to lift perishable stock out of harm's way. In a previous flood incident, the water was deeper, going (higher) into the back of the shop and, because Mark was not around to save it, stock was damaged. Mark has supplied various photos.

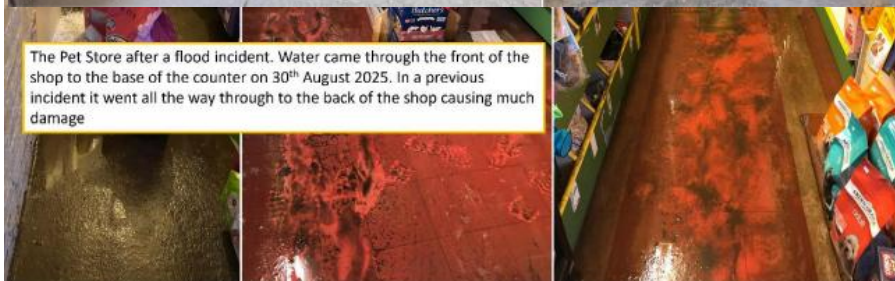
On Left:  
Adrian's Bike Shop floods with water running through the archway from the road and accumulating in front of the bike shop.

There is a long (5metres) drain in front of the shop which takes the water to a pipe going beneath the

premises and thence to the culvert at the back. When the culvert is full, there is nowhere for the floodwater to go to other than into the shop.

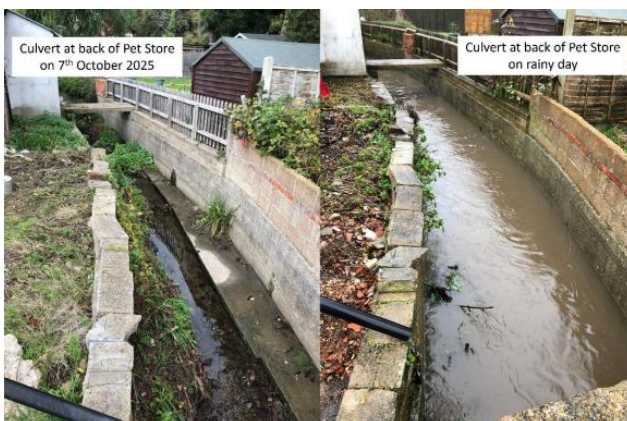
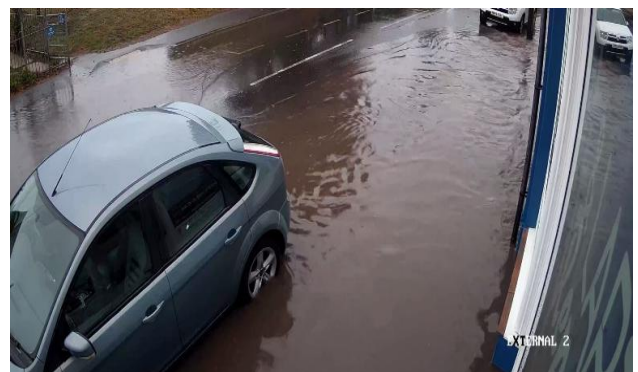
On Right: Patch Computers has been flooded, with water coming into the premises, damaging stock on the floor and blowing the electrics. The external photo from their CCTV system illustrates the situation.

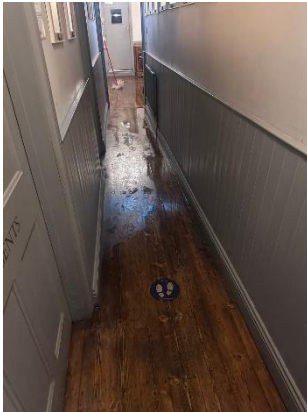
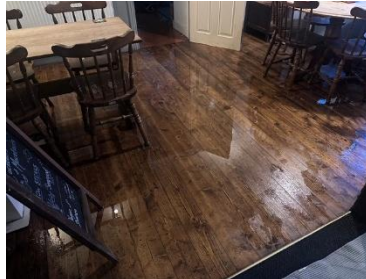
**The Vine Inn has suffered flooding several years running.**

The water rushes down the Avenue and meets water from

Queens Road and Tennyson Road just outside the pub.

The pub becomes flooded.

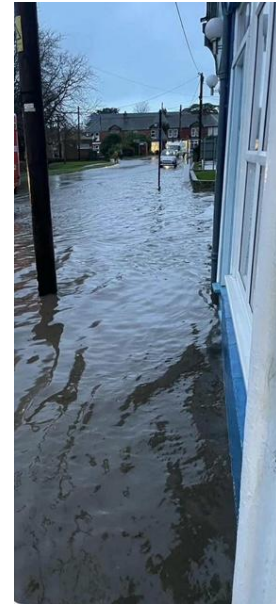
**Right: Outside Library on School Green Road**

**This flood water then travels down to School Green Road and meets water coming down from Longhalves Lane, Dall Square, Parkers Hill and Bannermans Path.**

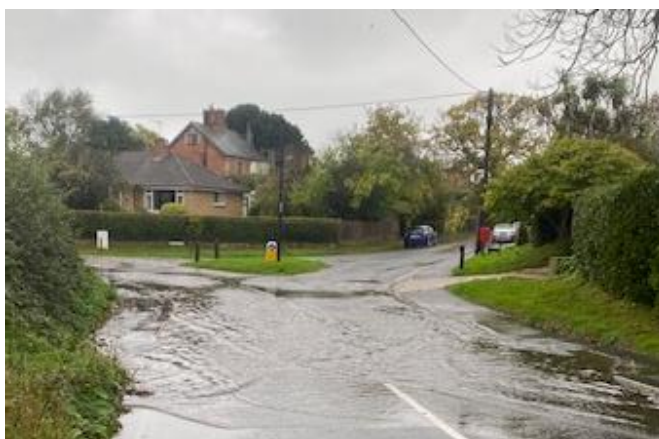
### **Camp Road**

**These pictures show flooding at junction of Camp Road, Victoria Road and Stroud Road. This is a regular flooding occurrence.**

**This was the site of an accident on 02/03/2014 where an elderly man was knocked over on the junction of Victoria Road/Camp Road to**

avoid the flood. He suffered dramatic life changing injuries, with numerous breaks, and later died of his injuries.

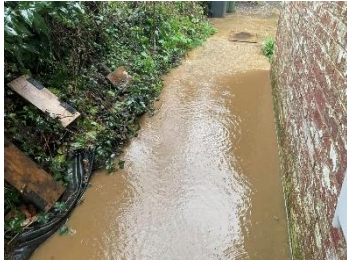
**Left: Mole Cottage, Camp Road**

*The owner said, "We already experience flooding from field run off water from the field and can be deep enough to flood into our property."*

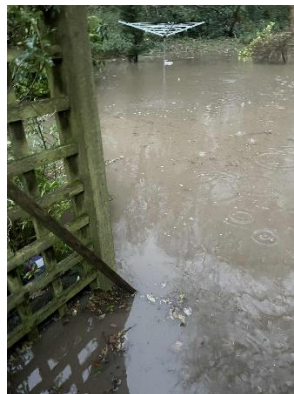
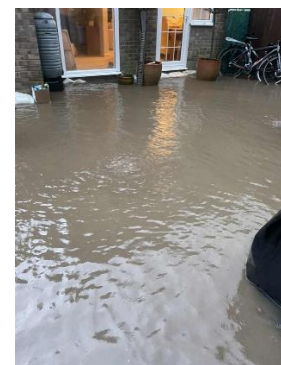
**Pictures showing the back garden where the culvert, that is under the house, is overwhelmed with the sheer amount of runoff water from Golden Hill Fort and Kings Manor land. The flood water comes through Christmas Tree wood on to the land at the back of the property.**

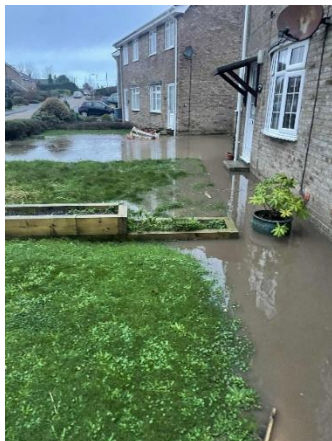
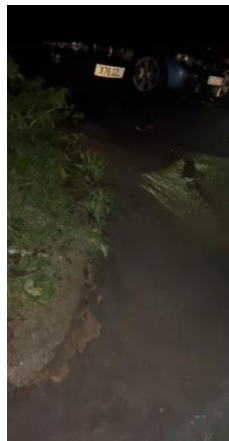
**This is the area where the pipe comes from Kings Manor Land, under the path, onto the land of Christmas Tree Wood. It joins the water coming down from Golden Hill Fort and travels down to the culvert under the house of 94 Collards Close.**

**The flood water travels through and round the property, into Collards Close and down to Longhalves Lane/Parkers Hill/Dall Square/ Bannermans Path.**

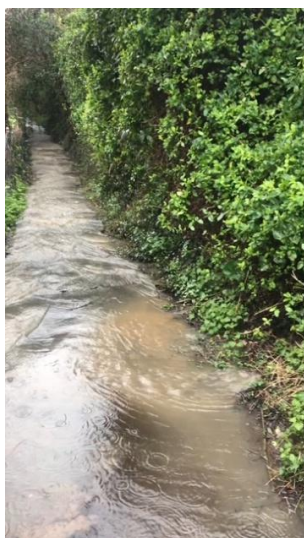
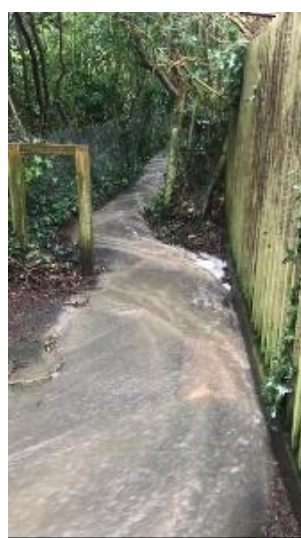
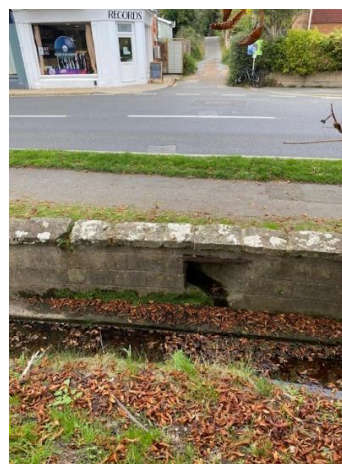
### **Longhalves Lane/Parkers Hill / Bannermans Path:**

The paths are all overwhelmed with the sheer volume of flood water. Ditches need to be added; other ditches need clearing and digging out. Someone has built over a ditch with a car hard standing area - restricting the flow leading to the culvert.

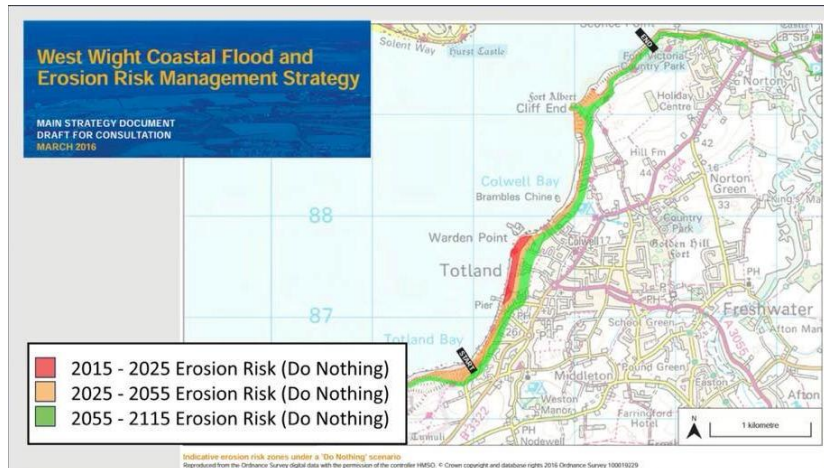
### Colwell/Totland Area

This map shows the **landslip-prone coastline between Totland and Colwell**, where historic properties have long discharged grey water through the cliff face, contributing to instability and landslip.

Under current regulations, **new properties are no longer permitted** to discharge grey water into the combined sewer in this way or via the cliff. As a result, further development in this high-risk zone is **no longer viable without substantial, compliant drainage solutions**, reinforcing the argument that this coastline is unsuitable for intensified development and must be managed primarily for stability, safety, and environmental protection.

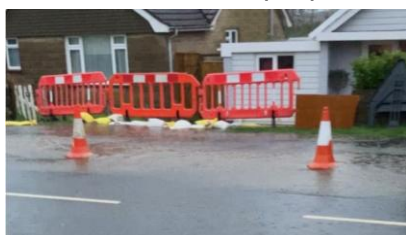
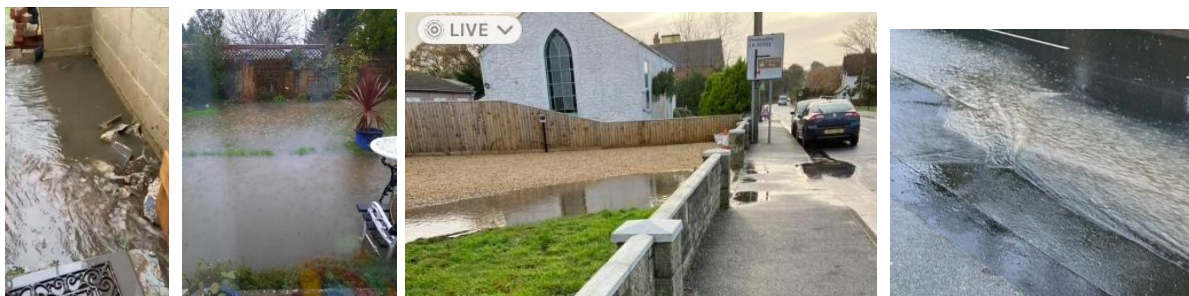
The water runs off the field in Birch Close and the new Meadow Way development. Houses and garages lower down with sloping driveways are now overwhelmed with flood water. Water from this area doesn't flow into Freshwater basin other than through the Southern Water network. New developments have overwhelmed this old drainage network. Maderia lane hasn't any drainage as it is unadopted road, so it relies on culverts and ditches. Some ditches have been filled in leaving houses and gardens at risk and residents have had to fit Anti Flood devices (Non return valve) to protect their homes.

Photos show local properties trying to prevent flooding and flooded gardens/roads:

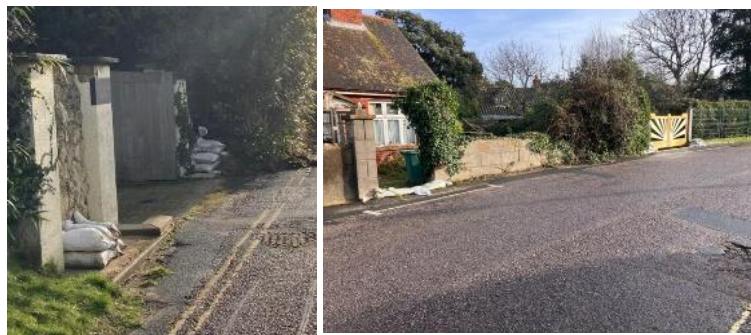
### **Colwell chine Road**

**Water runs down from the common through the chine. Houses can now be seen with sandbags; owners trying desperately to prevent flooding to their properties.**

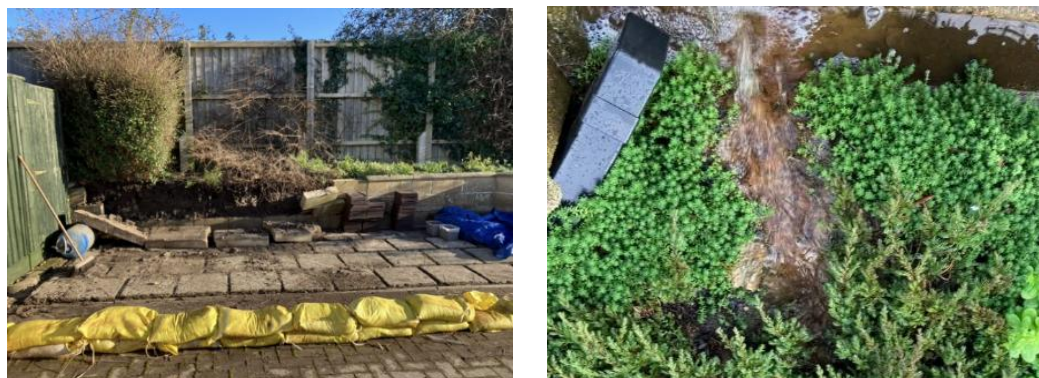
### **Birch Close**

**The field behind Birch Close is higher than the surrounding land. The field levels were altered with development and since then the neighbouring gardens and property have been flooded. The weight of the flood water coming off the field destroyed a garden retaining wall.**

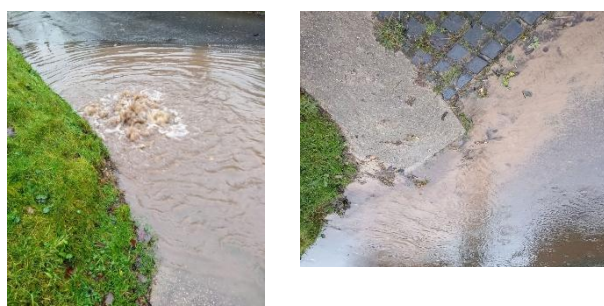
### **Blackbridge Road**

**Floodwater comes off Tennyson Downs and along down Blackbridge Road. Overwhelming drains and enters the marsh. If the marsh is full, it causes flooding at the Blackbridge.**

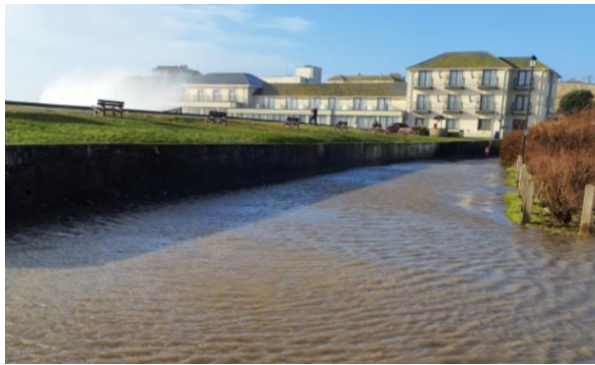
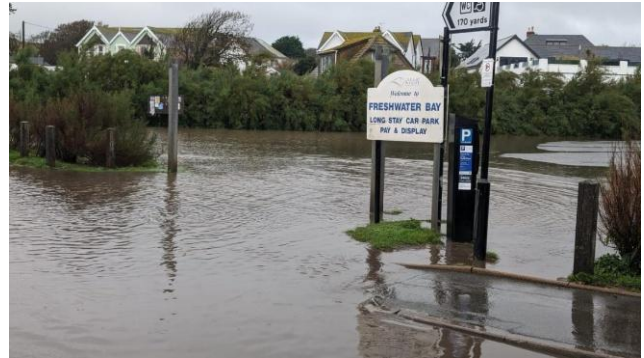
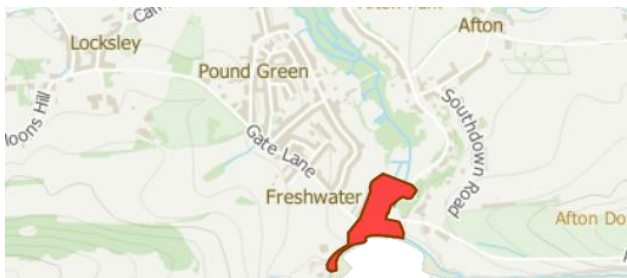
## **Freshwater Bay**

**Water enters Freshwater Bay floods from either storm water coming down from Tennyson Downs or sea water from storm surges, when it overtops the sea wall at Freshwater Gate. The storm surge delivers Sea water and**

**shingle that can transiently block the head and raise flood levels.**

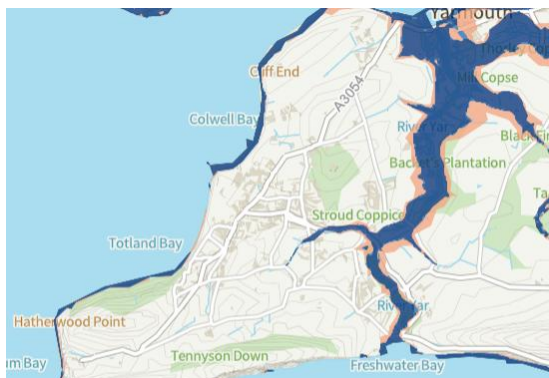
**Figure A:** Flood Zones 2 & 3 (fluvial) — predicted extents.

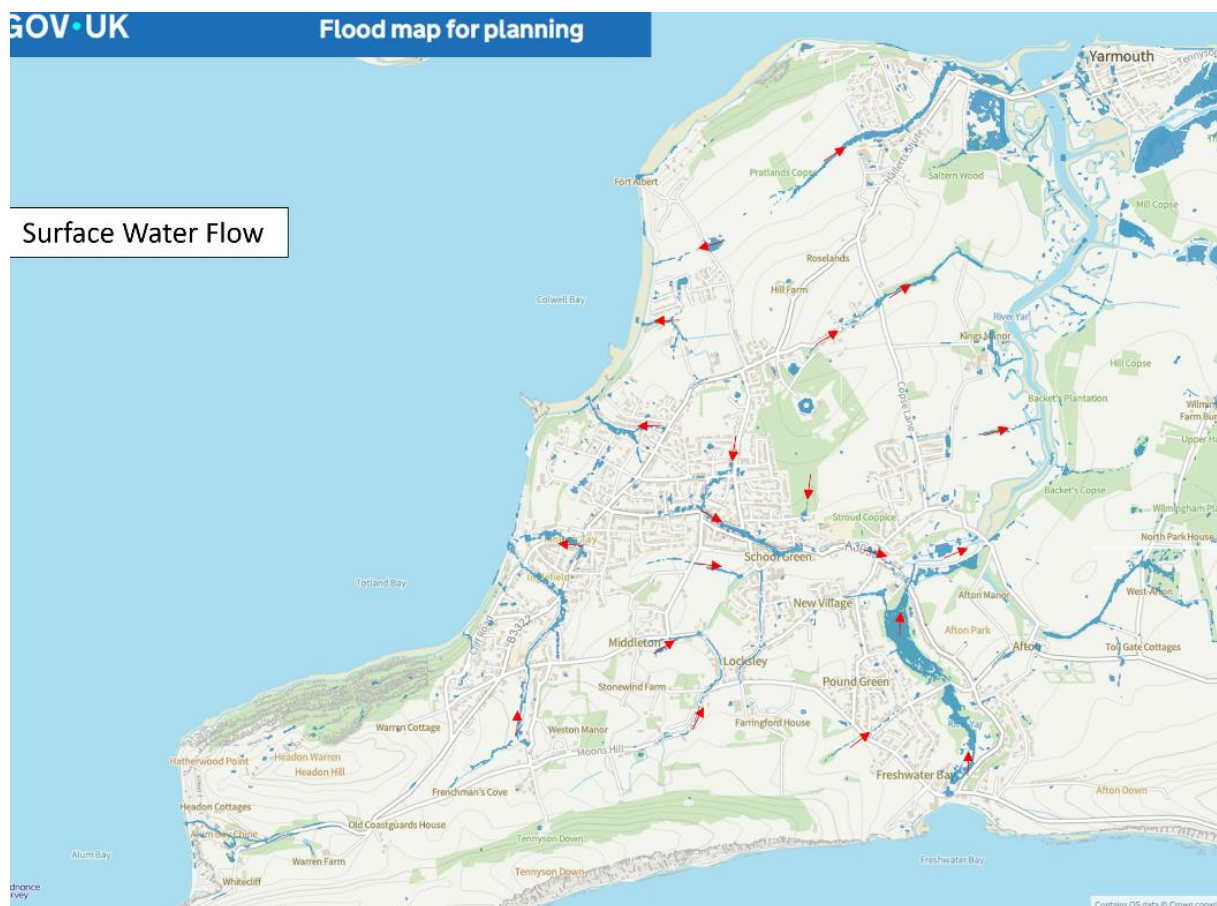
**Figure C:** flow paths and storage areas.
